**APPLICATION OF GEO-INFORMATICS FOR NATURAL DISASTERS  
MANAGEMENT IN THAILAND**

**Submitted by Geo-Informatics and Space Technology Development Agency  
(GISTDA), Thailand \*\***

# **Application of Geo-Informatics for Natural Disasters management in Thailand**

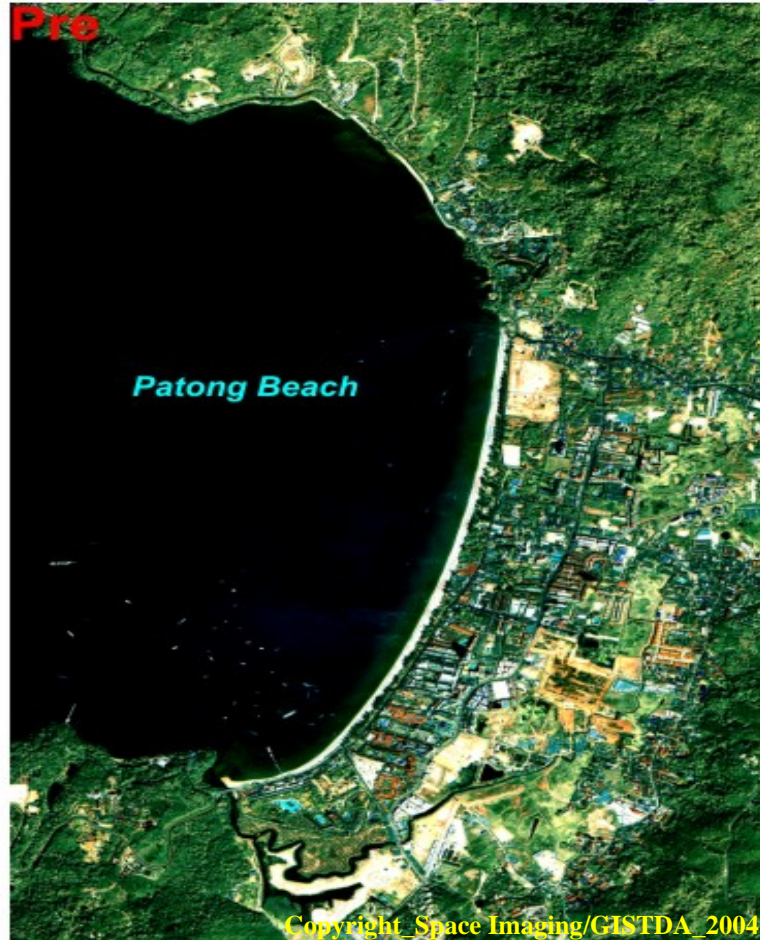
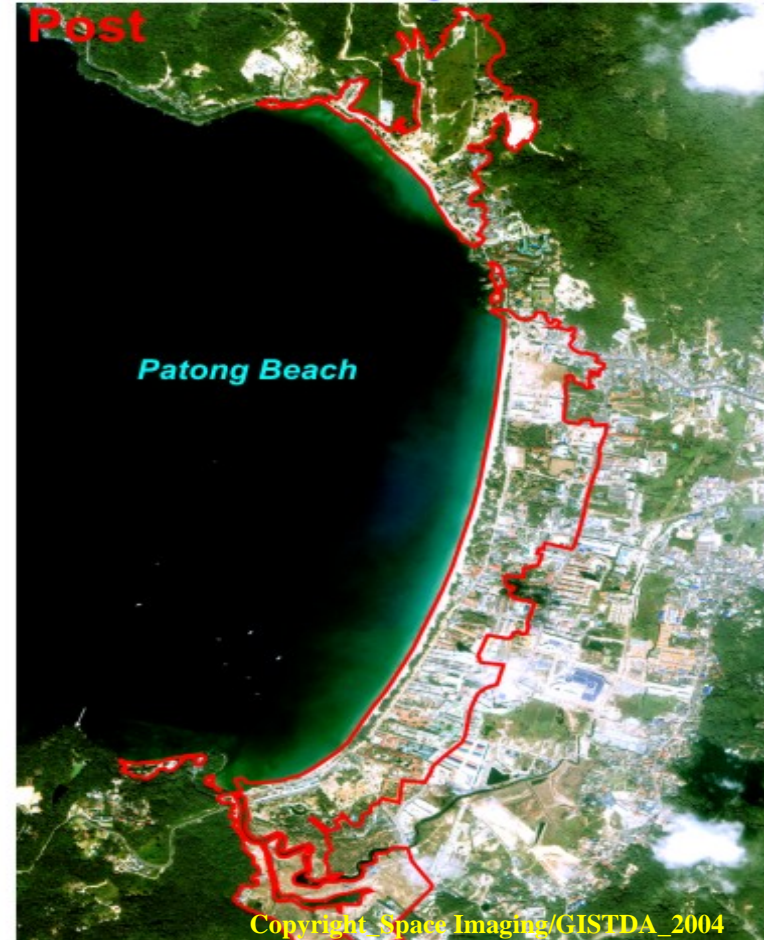
### 1= The Seaview Patong

**Figure 2** Two period natural color composite IKONOS images (24 and 28 December 2004). Yellow vector indicates sand beach and beach bank erosion at lower part of Patong beach, Phuket province.

Damage caused by tsunami is mostly severe at shoreline where boats, harbors, road networks, buildings, and utilities were destroyed. Besides, aquatic life, plants, animal and human in the near shore environment may also be devastated. Multi – date satellite data are found to be very useful to monitor a coastal shoreline changes (Figure 2 – 3). Figure 2 shows an affected area (red boundary) of IKONOS image of Patong beach, Phuket province. We found that the wave could reach in land area approximately 480 meters from the shoreline. Sand beach and beach erosion at lower part of Patong beach was enlarged and displayed the erosion as yellow vector in Figure 3. Also, river damage and sand bank damage, large run – off and strong waves caused erosion of river and beach bank at Kammala beach, Phuket province.

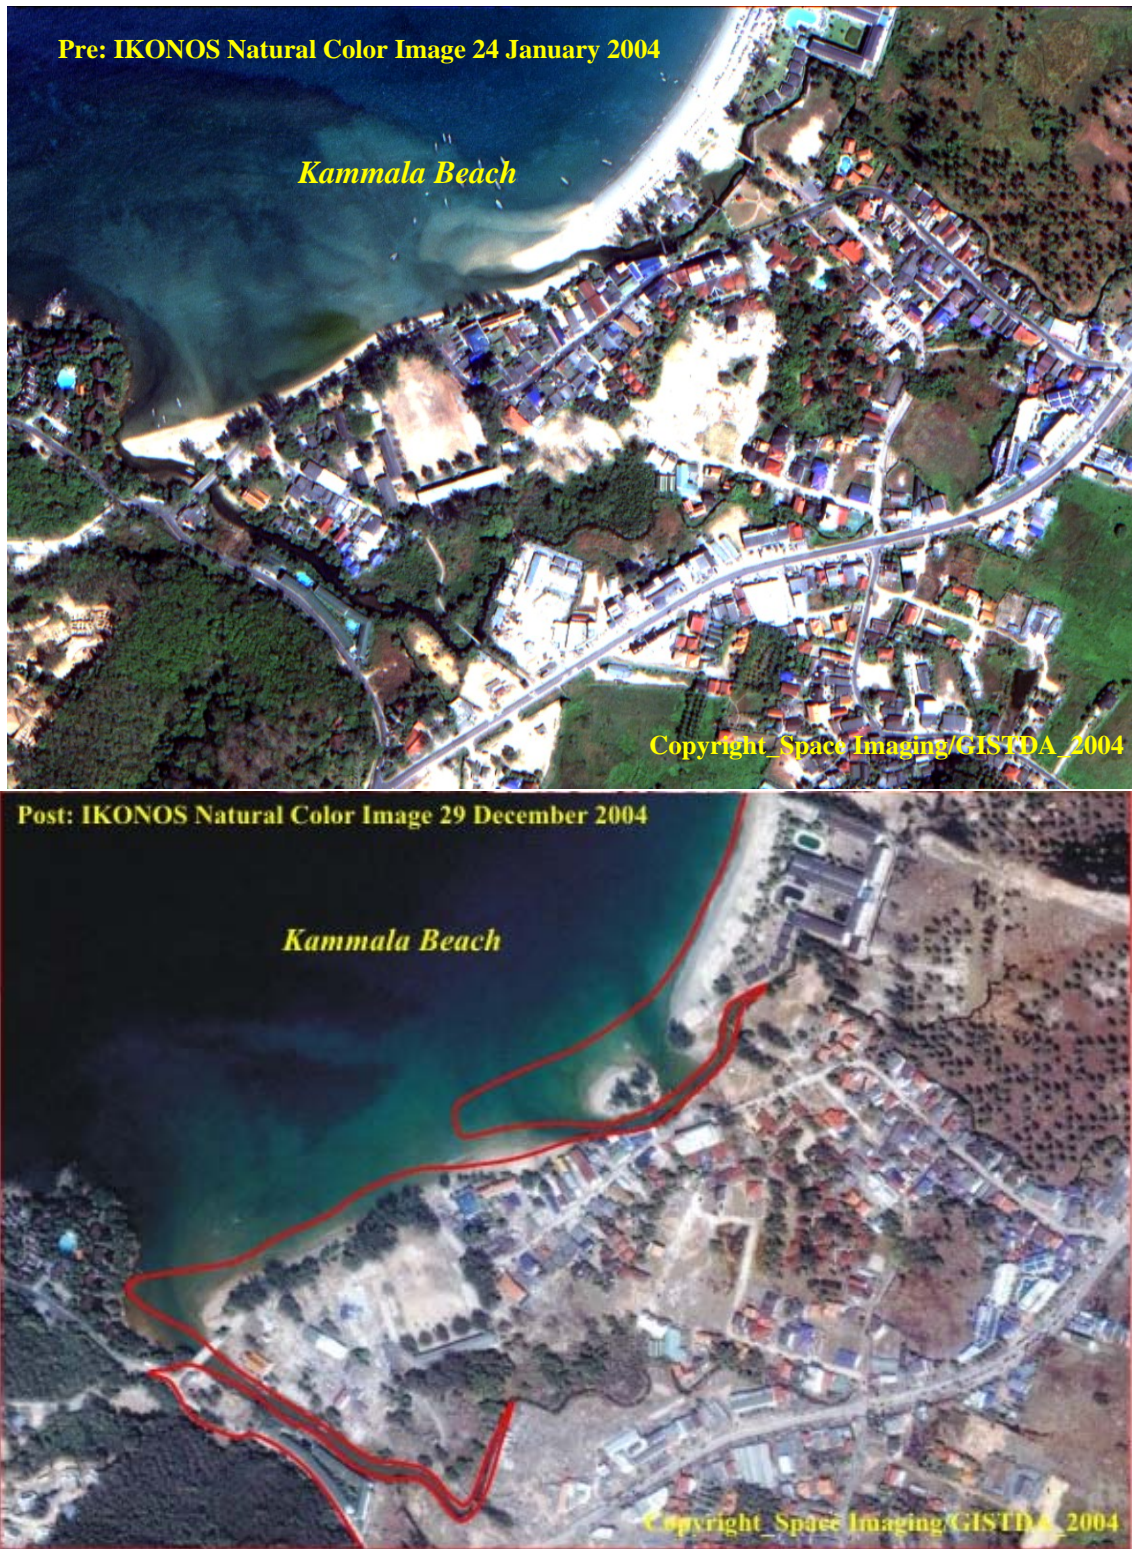
**Figure 3** Pre and post natural color composite IKONOS images of Kammala beach, Phuket province taken on January 24, 2004 and December 29, 2004 showing before and after shoreline and river bank erosion in red and yellow respectively.

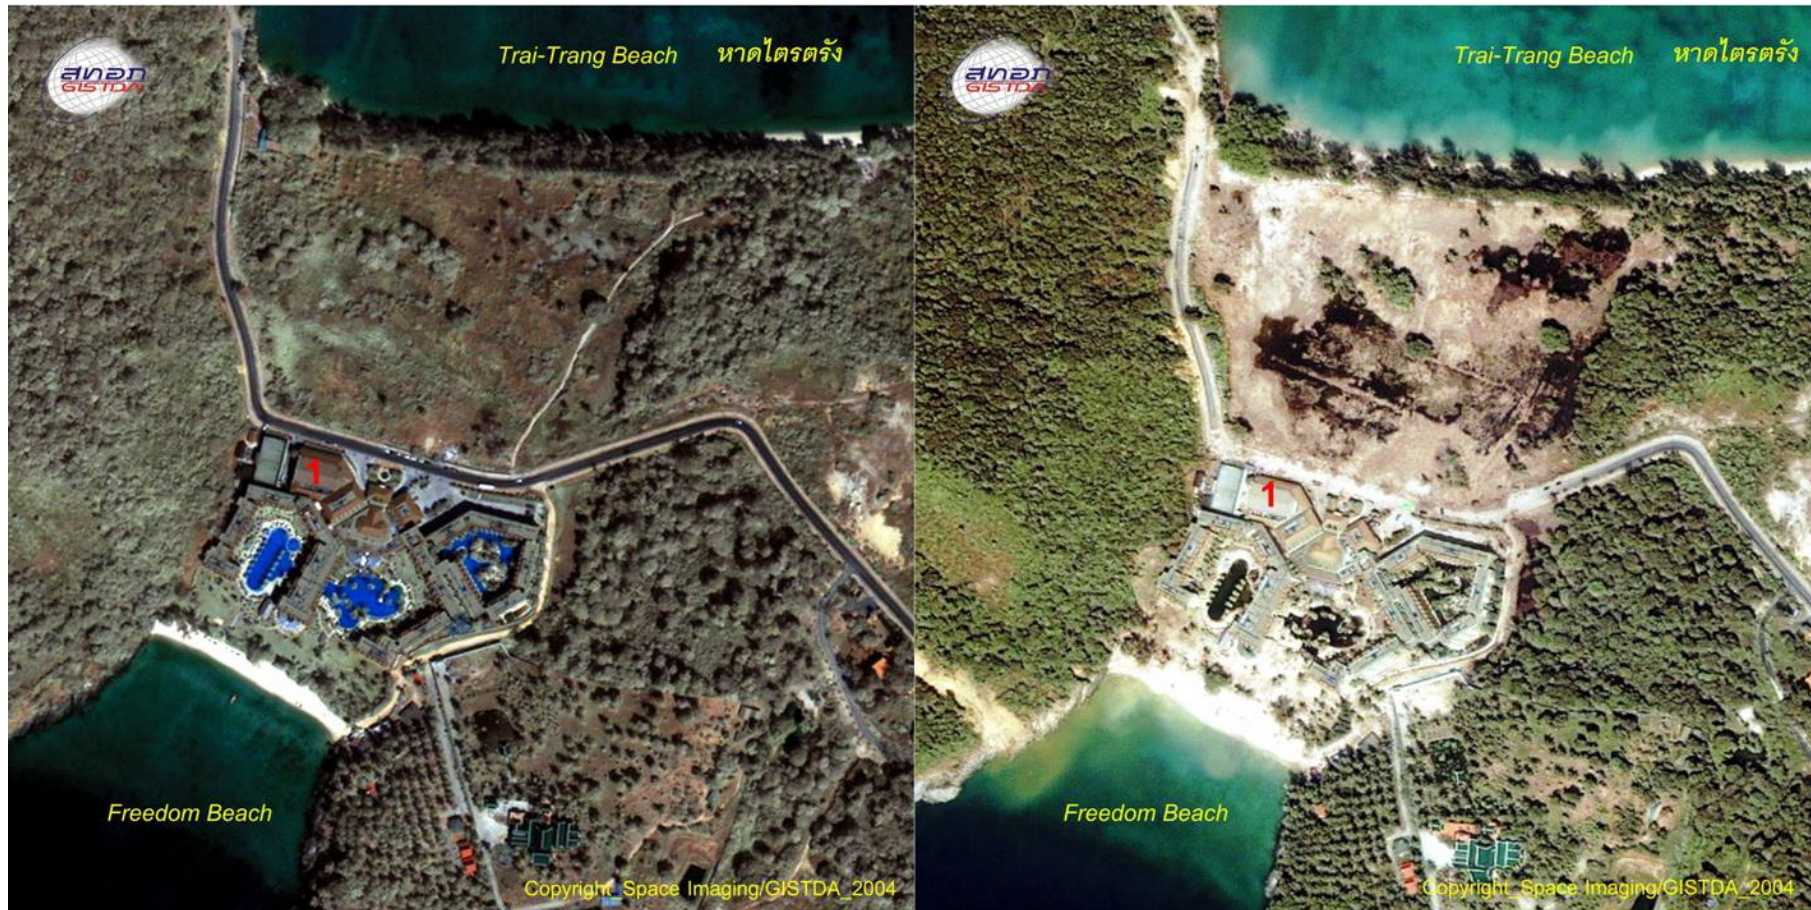
**1= The Merlin Beach Resort**

**Figure 4** Pre and Post images of IKONOS showing a changed area of Merlin Beach Resort at Tri Trang beach, Phuket province. Also damages to buildings, swimming pools, roads, shorelines and shrub forest

All constructions including buildings, road networks, bridges, aqua-cultural farms and ships were completely washed away by the Tsunami wave in many places such as Phang-nga coastal, West coast of Phuket island, Ranong, and Krabi province. At Tri Trang beach, Phuket province, where the wave washed the buildings, roads swimming pools, beaches and shrub forest away and damaged by huge sand and woods transported by wave and Figure 4 shows severe Tsunami damage and many ships were dragged 600 - 700 meters from the coast at Ban Nam Khem, Phang-nga province. Detail of perspective IKONOS image is essential for reliable landscape of general affected area and effective in visualizing the affected area. From these images can make us more understand how the waves spread over the coastal flood plain. Phang-nga coastal plain is a shoreline of submergence, most of coastal is mostly narrow, flanked by steep slopes. The shoreline is usually quite irregular with many bays and inlets. Various of tin placer deposits are generally found on alluvium plains which originated from alluvium transported from eroded granite mountains and in shallow coastal sea and also, human settlement are possible and popular on those shorelines (Figure 5). Beach bank erosion and buildings submerged by the wave (water) and bridge and roads were washed away of South Sea Coral and Spa Resort, Phangnga province showing by IKONOS images. Classified map displayed an affected area by Tsunami with yellow boundary along Phang-nga coastal plain from natural color composite IKONOS images highlighting from Laem Krang Yai to Ban Khao Lak. Some place as Ban Bang Sak, Bang Muang sub district, Takua Pa district, the wave could reach approximately 550 meters at elevation 10 meters above mean sea level, the wave reached 2,200 meters distance from the shoreline at Ban Bang Niang, Takua Pa district, Phang-nga province.
